Case 303 : Narrative

Case Vehicle (A): 1999 Buick	Vehicle (B): 2001 Chrysler
Type: LeSabre, 4-door sedan	Type: Town & Country, passenger van
Driver: 39-year-old female	Driver: 66-year-old male
CDC: 01-FDEW-3	CDC: 99-0000-0

CASE NO.: UM-4047-01

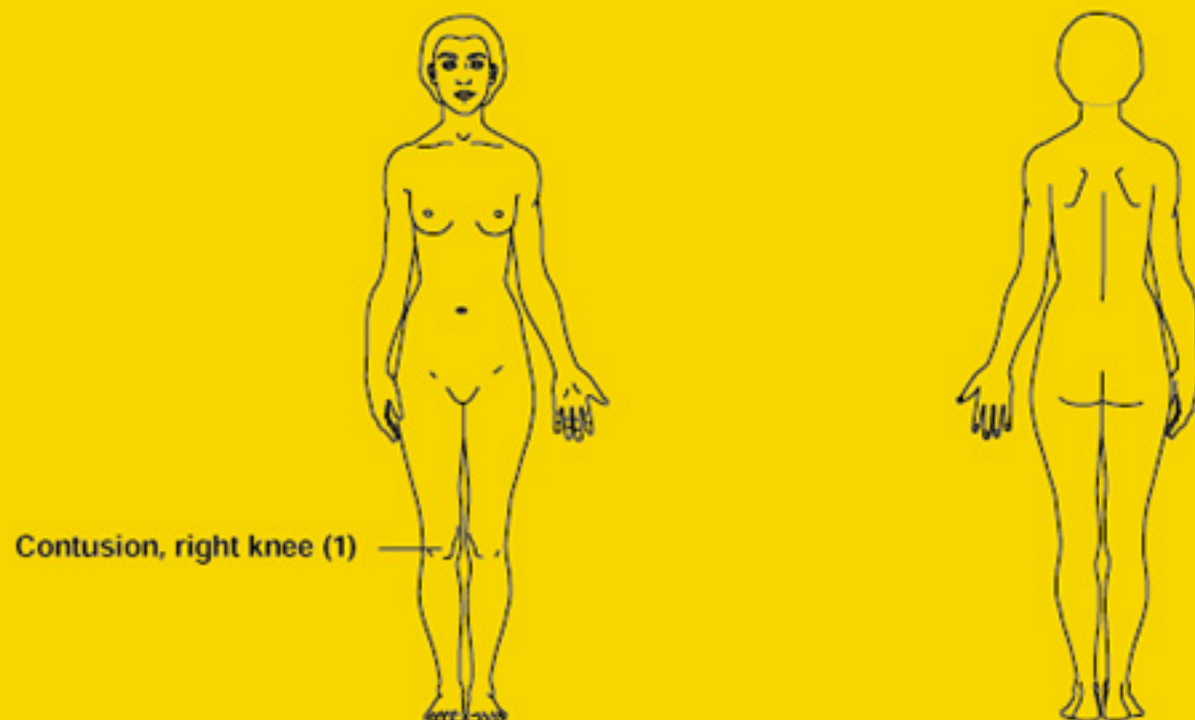
Occupant: Driver	Age: 39 years	Sex: Female		
Restraints: 3-point belt not worn; airbag deployed	Stature: 168 cm (5 ft 6 in)	Mass: 75 kg (165 lb)		
Injury Description	A.I.S.	Injury Source		
—	—	Definite	Probable	Possible
Contusion, right knee	1	Knee bolster	—	—
Maximum A.I.S. Level	1	—	—	—
Injury Severity Score	1	—	—	—

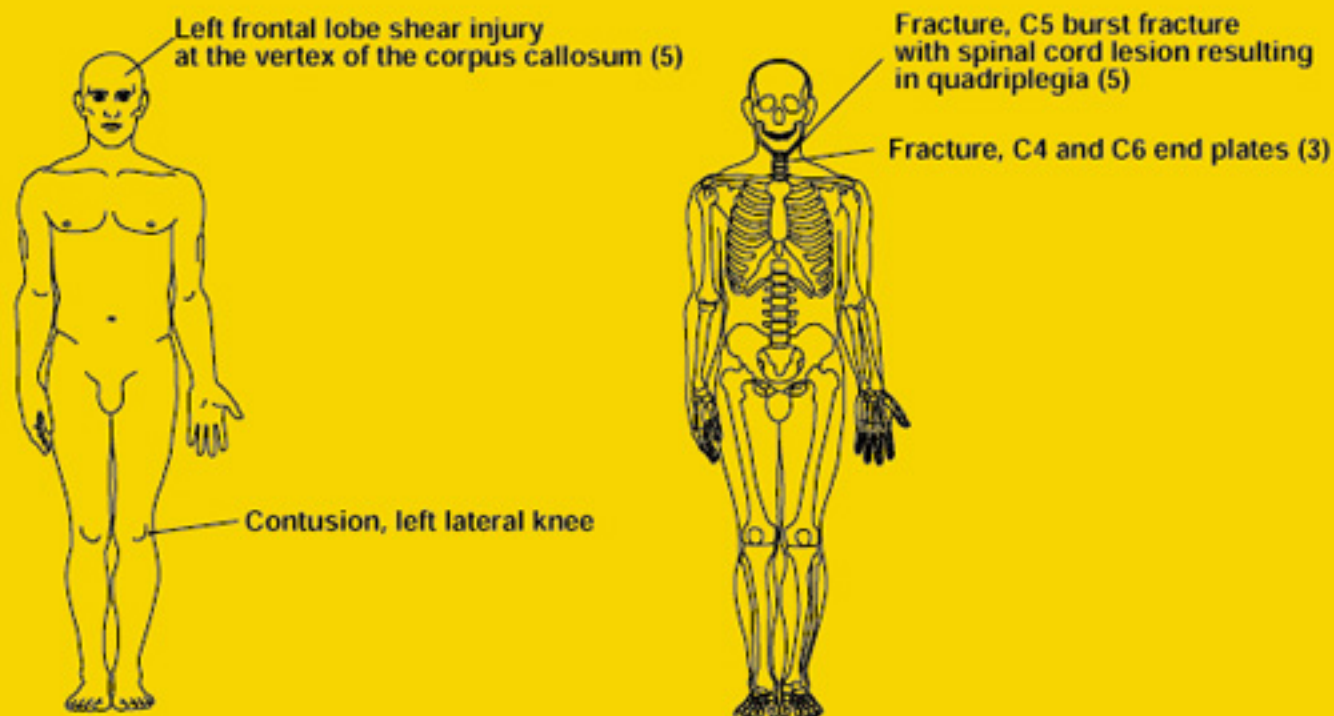
Occupant: Right Front	Age: 77 years	Sex: Male		
Restraints: 3-point belt not worn; airbag deployed	Stature: 170 cm (5 ft 7 in)	Mass: 77 kg (170 lb)		
Injury Description	A.I.S.	Injury Source		
—	—	Definite	Probable	Possible
Shearing-type injury to the left frontal lobe at the vertex of the corpus callosum	5	—	—	A-pillar
Fracture, C5 burst fracture with spinal cord lesion resulting in quadriplegia	5	—	—	A-pillar
Fracture, C4 and C6 end plates	3	—	—	A-pillar
Contusion, left lateral knee	1	Glove box	—	—
Maximum A.I.S. Level	5	—	—	—
Injury Severity Score	25	—	—	—

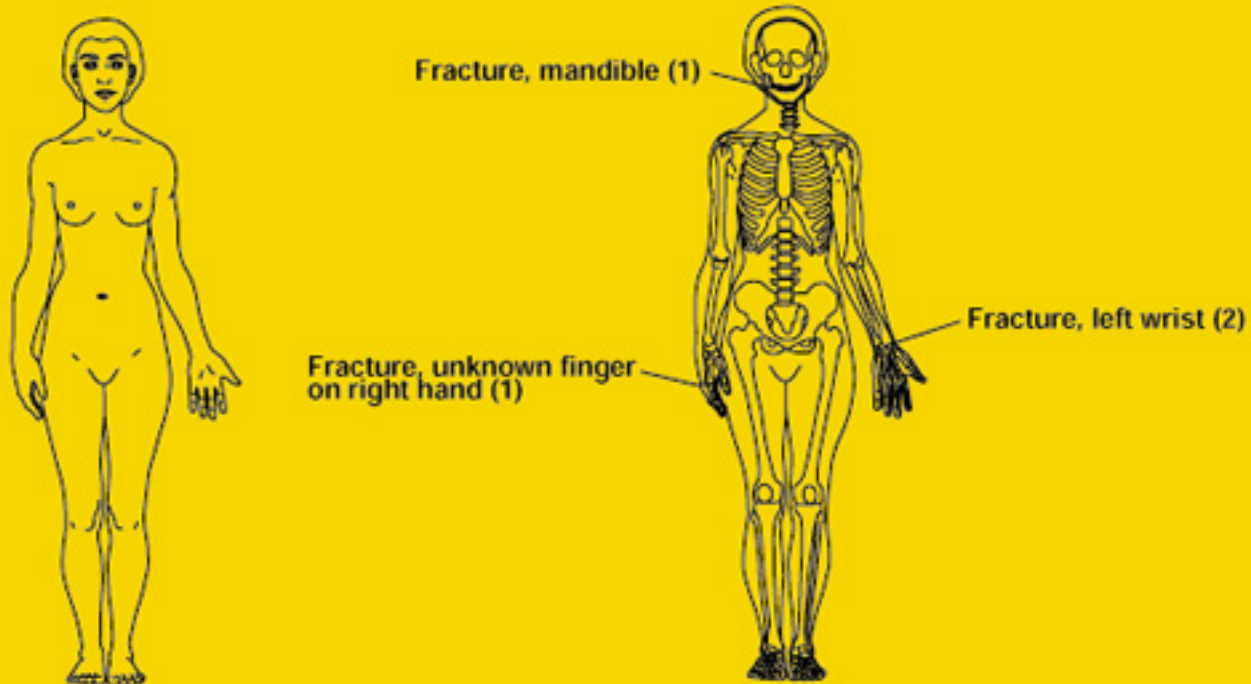
Occupant: Right rear	Age: 72 years	Sex: Female		
Restraints: 3-point belt not worn	Stature: 163 cm (5 ft 4 in)	Mass: 61 kg (135 lb)		
Injury Description	A.I.S.	Injury Source		
—	—	Definite	Probable	Possible
Fracture, mandible	1	Seatback	—	—
Fracture, left wrist	2	Seatback	—	—
Fracture, unknown finger on right hand	1	Seatback	—	—
Maximum A.I.S. Level	2	—	—	—
Injury Severity Score	5	—	—	—

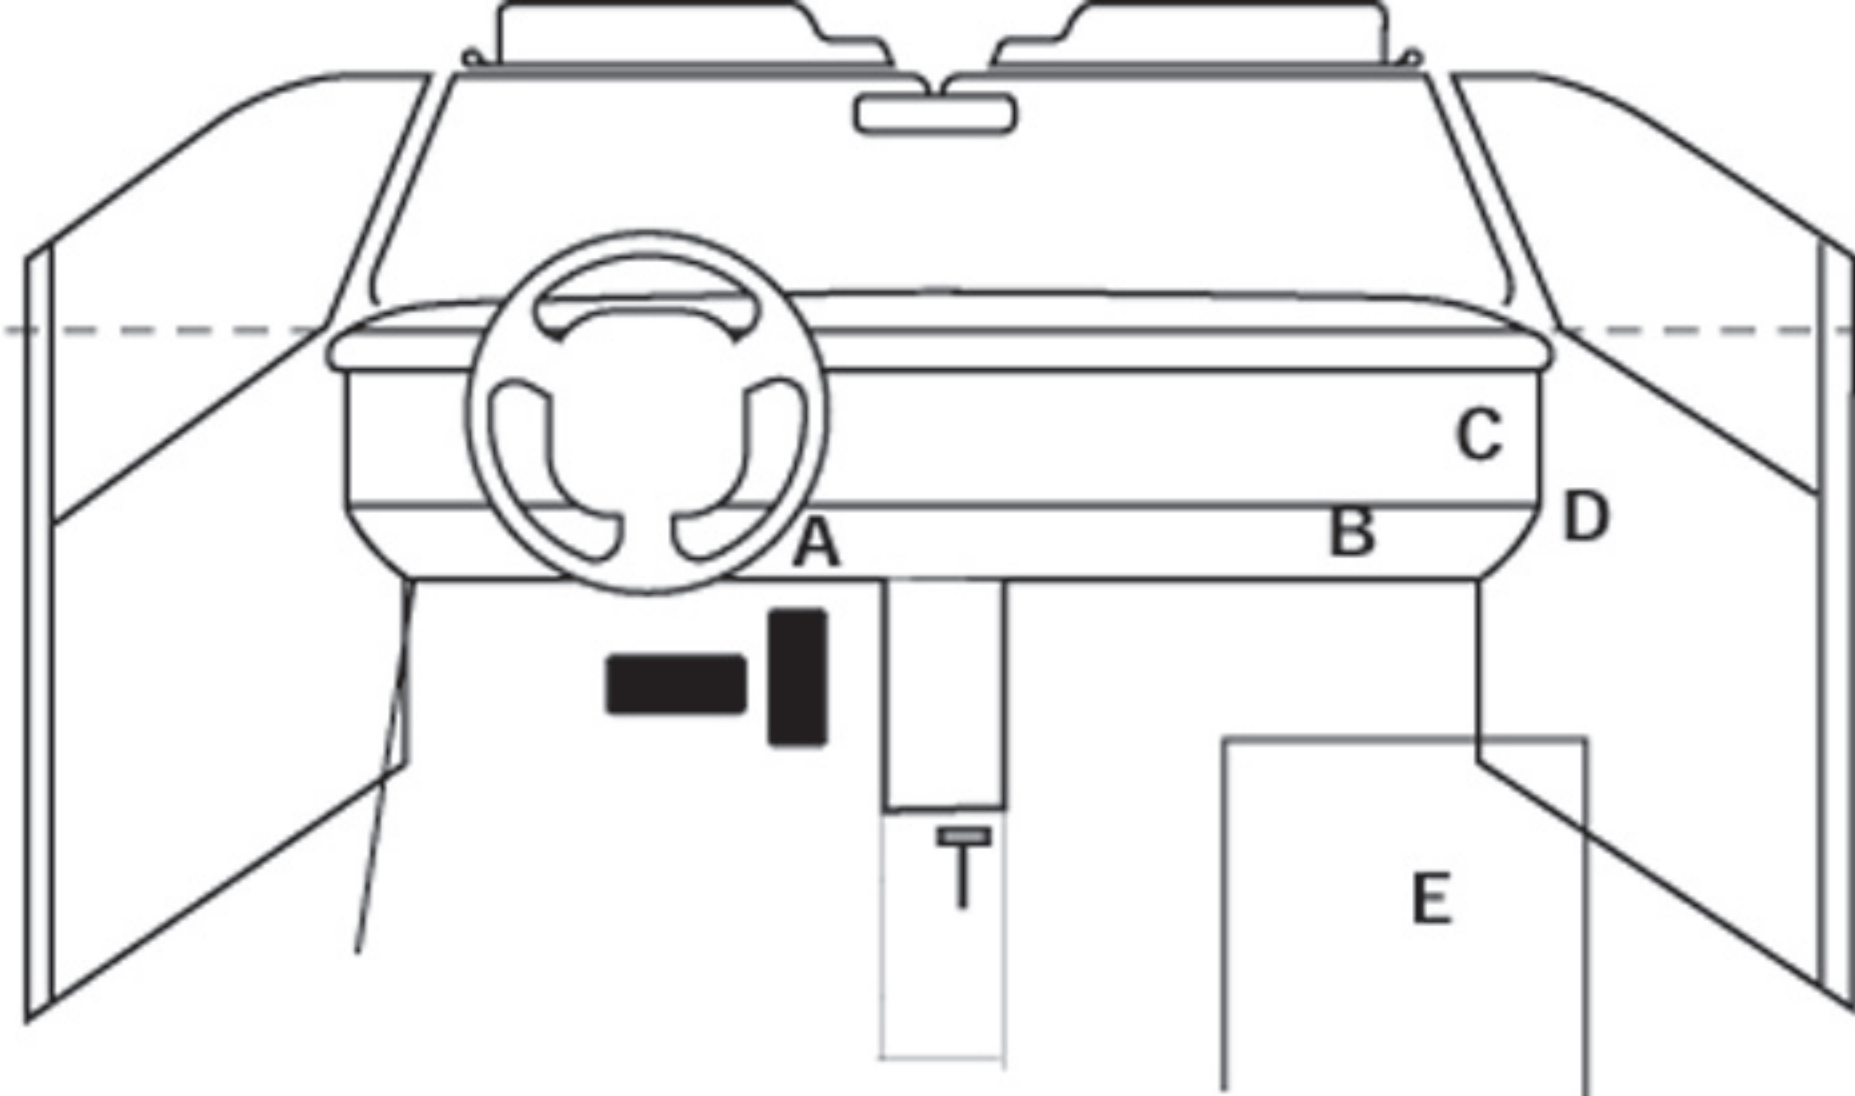
OCCUPANT CONTACT WORKSHEET

Contact	Interior Component Contacted	Occupant No. if Known	Body Region if Known	Supporting Physical Evidence	Confidence Level of Contact Point
A	knee bolster	Dr	Rt. knee	scuff mark	1
B	Glove box	RF	Lt. knee	scuff mark	1
C	mid IP	RF		scuff mark	1
D	Door panel	RF		scuff mark	1
E	RF seatback	RR	Face, chest	deformed	1
F					
G					
H					
I					
J					
K

- A = scuff mark on knee bolster
- B = scuff mark on glove box
- C = scuff mark on mid IP
- D = scuff mark on right interior door
- E = right-front seatback deformed
